# Delta-Therm Ice Melt Cables Preserve and Protect Chicago Landmark

Melting snow and ice is normally done for safety concerns. But Delta-Therm's mineral insulated roof deicing cable assemblies went one step further to save the delicate exterior of a historic church in Chicago.

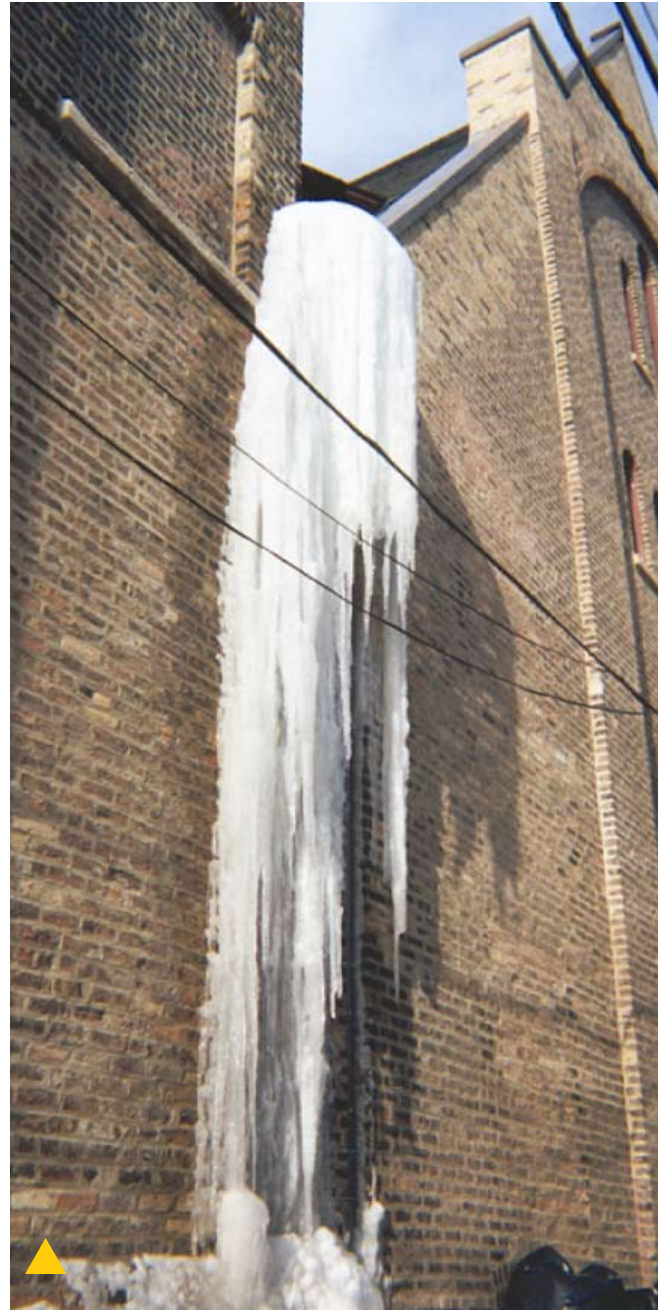
Water and ice were wreaking havoc, causing structural damage every winter to the delicate sandstone exterior. Possibly due to undersized downspouts and high gables, a frozen waterfall would form and cling to the north side of the building, shielded from sun by mature trees. The process occurred when snow and ice would fall, melt, and drip down the sandstone only to refreeze later in the afternoon or evening. Layer upon layer would build up, and soon it was apparent that the original sandstone exterior was being compromised. The frozen mass, said Miller, "was three times the actual size of the stone work at the corner." In addition, water was infiltrating over the southeast corner of the church, damaging interior and exterior walls. Rotted window frames, loose bricks, and gutters dislodging were all indicative of water damage and drainage problems that needed immediate attention.

Renovations at the church took place over a period of 10 years. To address the frozen waterfall, in 2001, 1,200 feet of Delta-Therm’s mineral insulated roof deicing cable assemblies were installed in a zig zag pattern, attached at the lower two feet of the lowest part of the gabled roof. Melt water was sent down a drain. “The roof deicing system was designed to be removable because they were going to replace the roof,” said Ada Cryer of Delta-Therm. When

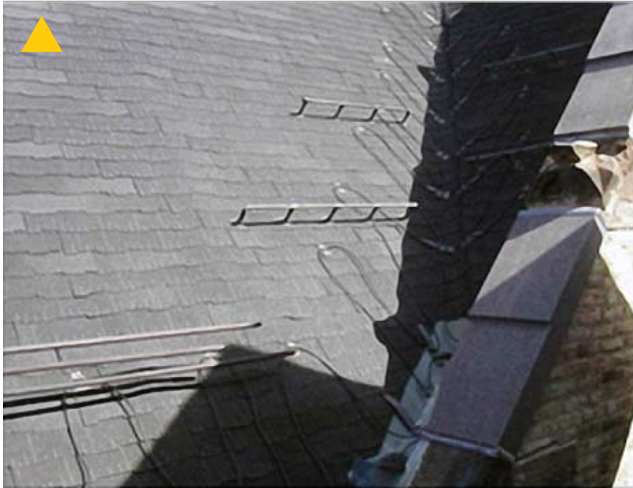
Delta-Therm deicing cable is installed behind the brick façade to create a heated drain path for snow melt water to follow.
